Special Report 77-29

# INFRARED THERMOGRAPHY OF BUILDINGS

## Qualitative Analysis of Window Infiltration Loss

Federal Office Building, Burlington, Vt.

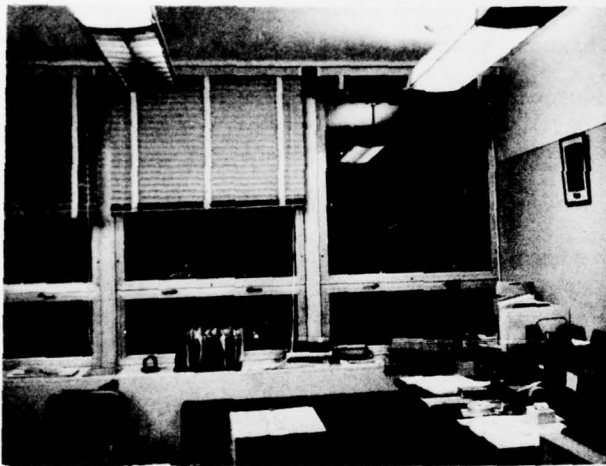
Figure 3.

Figures 1 and 2 show thermograms of two north-facing windows in Room 621 taken from inside the building. The infiltration (arrows) seen around these windows is typical of the condition observed at all of the randomly selected windows during the thermographic inspection of this building. Note that in Figure 2 the infiltration is more extensive than in Figure 1. The horizontal black line between the two arrows in Figure 2 shows cold

air leaking through the seal at the top of the opening window. Generally speaking, the air leakage at this location was not as severe as it was around the framing space of these windows. Figure 3 is a photograph of three windows in Room 621.

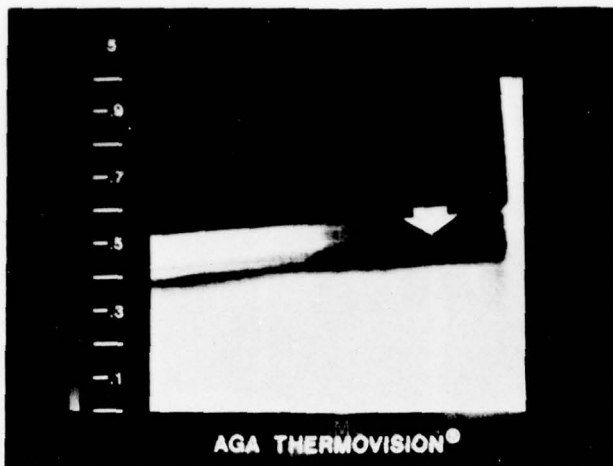
Figure 19.

Figure 18 is a thermogram of the top opening crack of a north-facing window in Room 234. The uniform, thin, black horizontal line indicates air leakage at the top opening crack, while the arrow points to excess heat loss at the glass/frame interface. The glass pane in the opening window shows leakage at two locations (arrows). Figure 19 is a thermogram of the lower right corner of the same window. While there is some cold air present at the sill/frame interface, the greatest heat loss (arrow) seems to be at the bottom right corner of the glass/frame interface.

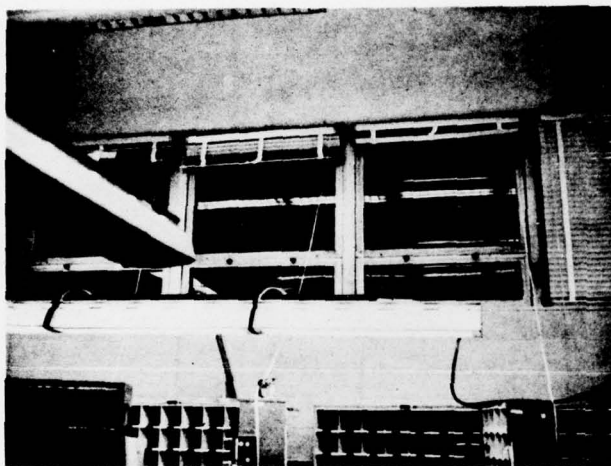
Figure 21.

Figure 20 is a thermogram of two south-facing basement windows in the Post Office workroom. Figure 21 is a photograph of these windows.
